A STUDY  
of  
IDEAL DRY PIPE VALVE

A T H E S I S

BACHELOR OF SCIENCE IN FIRE PROTECTION ENGINEERING

June 1, 1906.

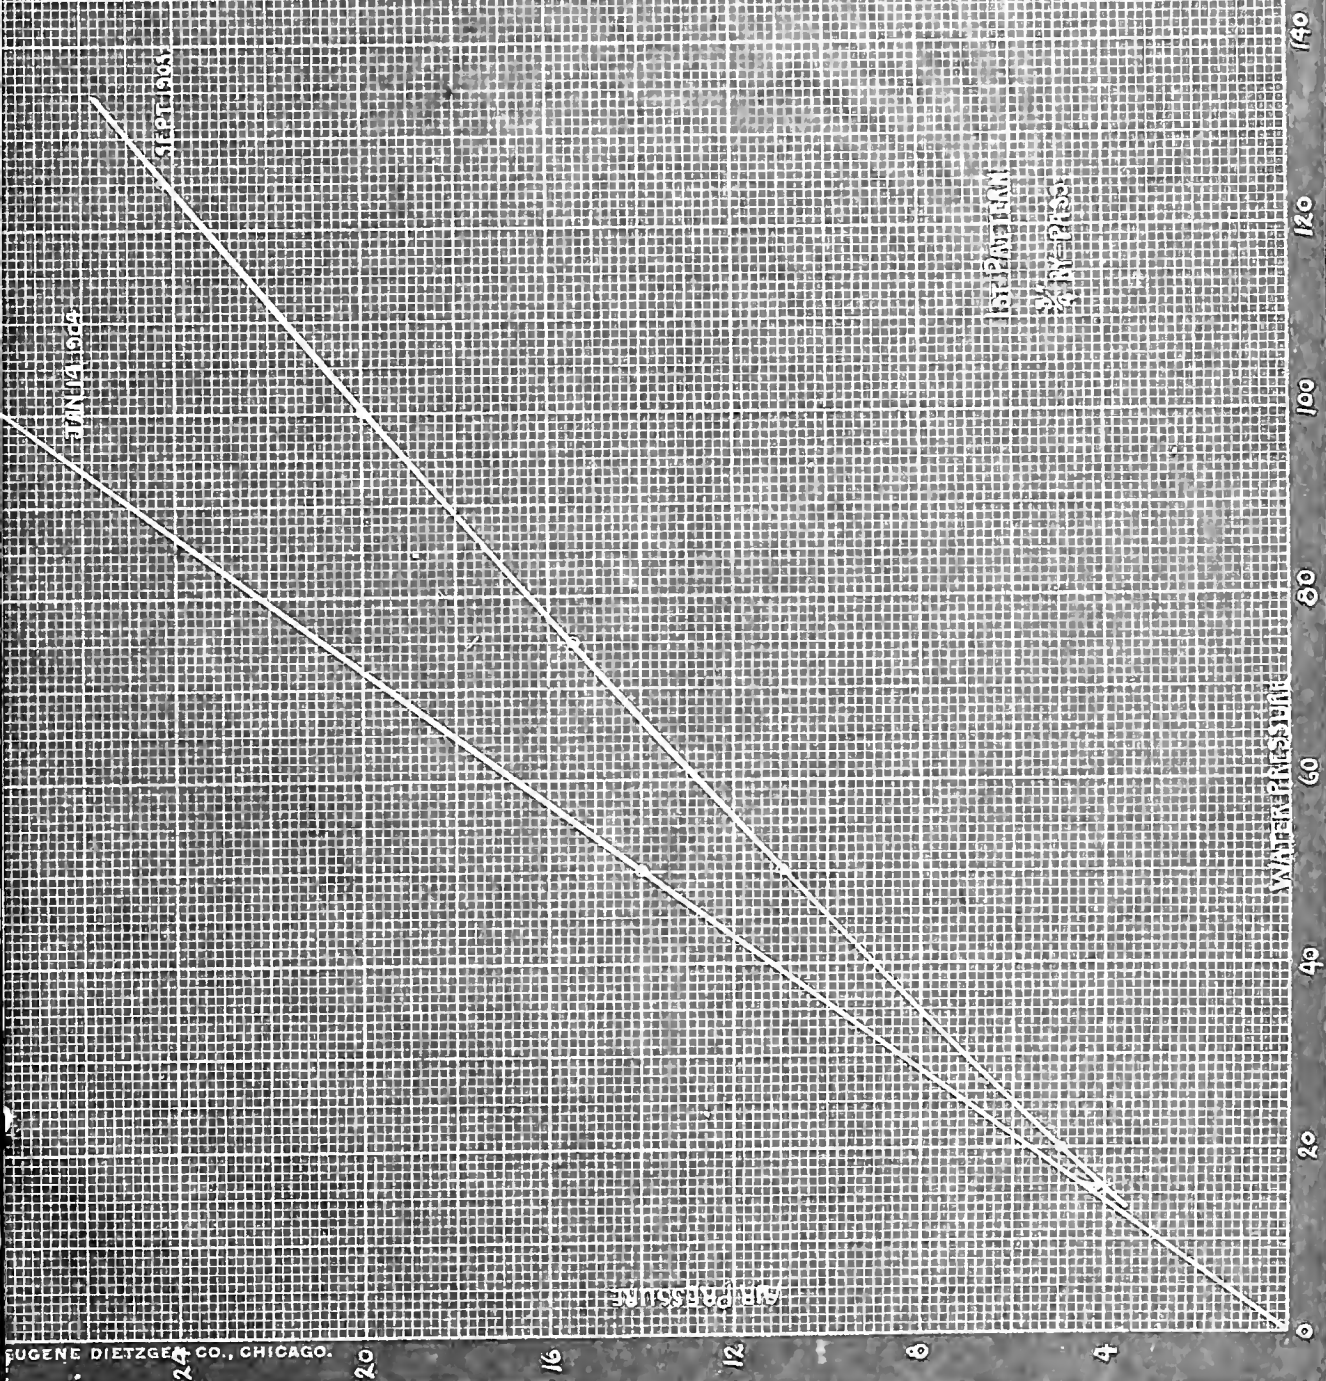
PLATE 4

Water hammer occurred at 38#, 58#, 67#, 87#, 113.8# water pressure. At all other pressures above 25#, movable member found jammed. Time necessary for system to equalize varied from 50 to 70 secs. Water hammer was also produced on suddenly opening discharge valve at those pressures where water hammer occurred on "firing". At the pressures which the movable member jammed, no water hammer resulted on suddenly opening the discharge valve. No doubt the jamming of movable member on "firing" prevented this, as will be seen later on. The seats leaked badly at all pressures. On account of the tendency of the movable member to stick on "firing", a series of tests were made with movable member not set but resting on bottom of chamber (F). The water pressure was raised to 80#. The discharge valve was suddenly opened. The object of this series of tests was to pick up movable member and produce water hammer.

Drop in water pressure over valve noted from gauge readings on air and water side found to be about 15# in all cases. As a rule, movable member was found jammed about 1/4" above rubber ring in chamber (F). At 76.9# water pressure movable member had turned a quarter of one revolution and was so tightly jammed that considerable force was necessary to loosen it. In most cases when movable member jammed it could be loosened by use of hand alone. Another curious

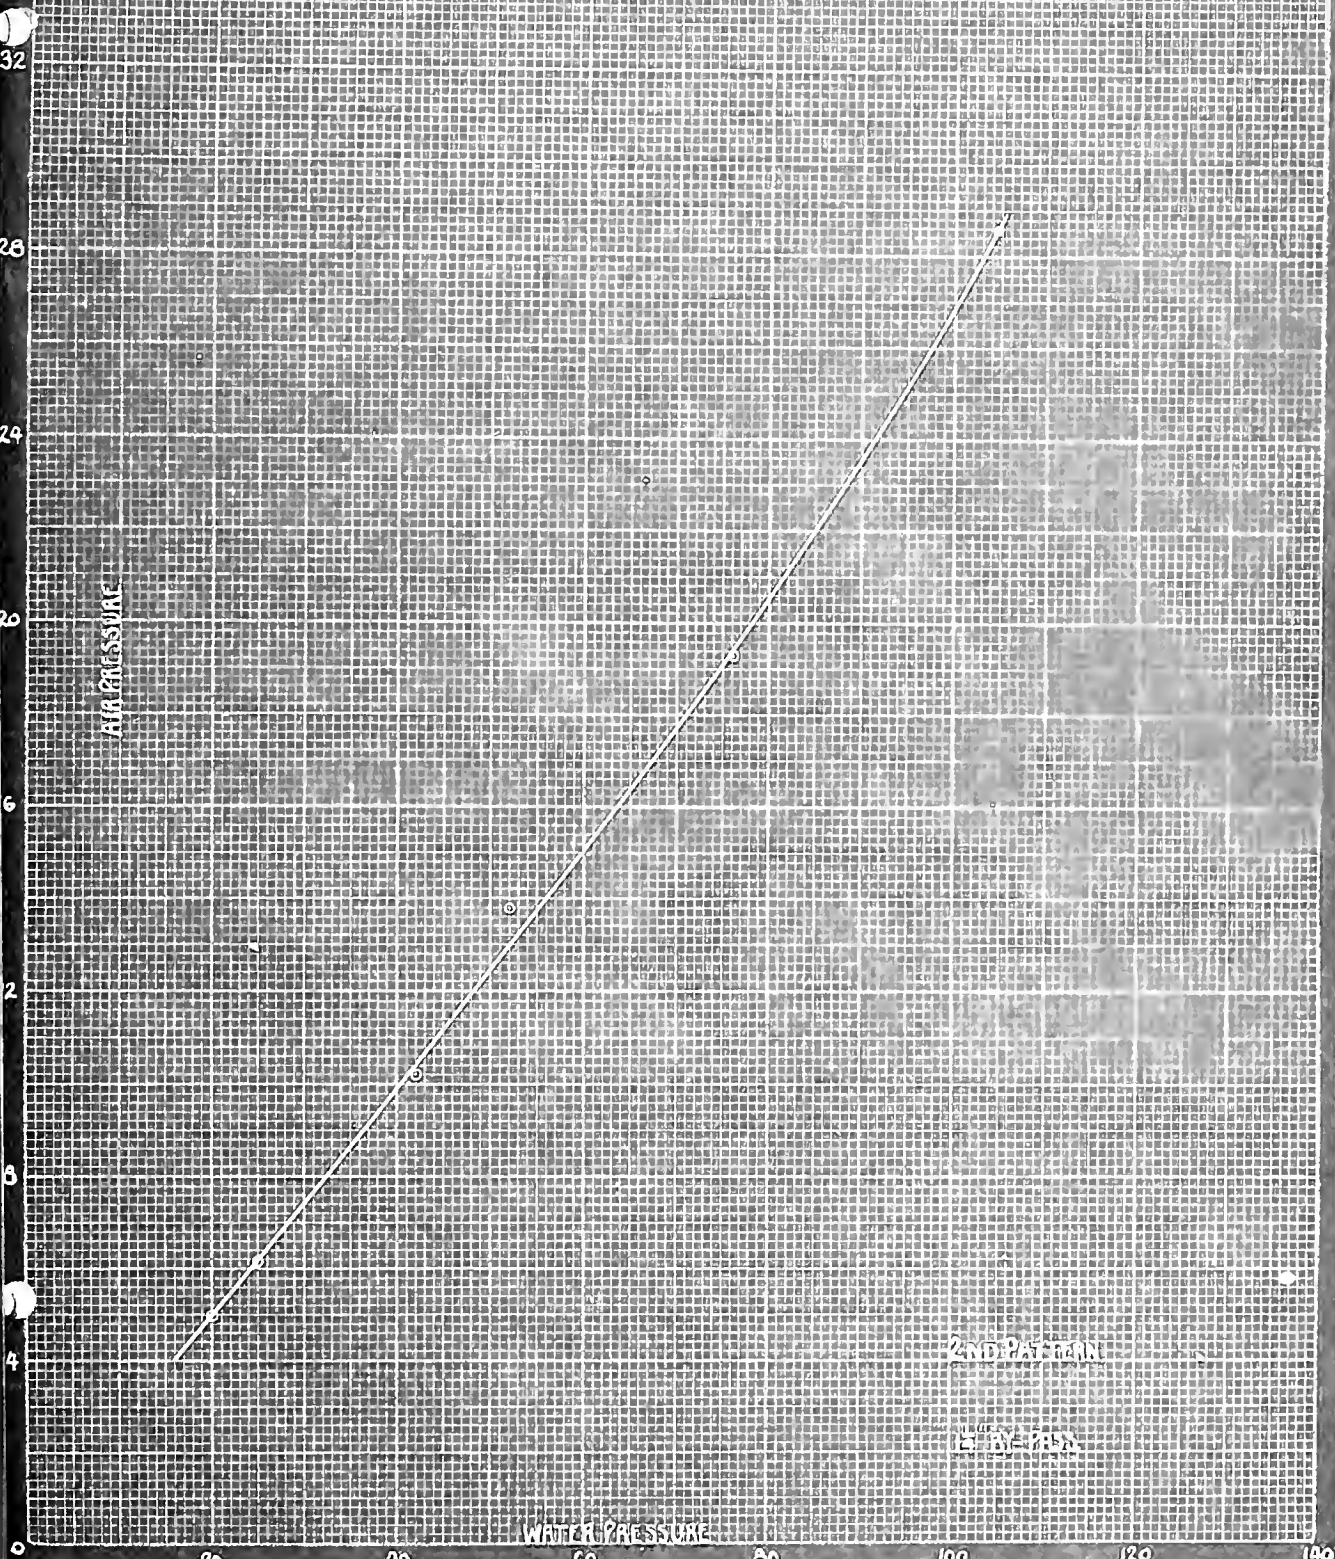
SECOND PATTERN. (1-1/4" By-Pass).

With this size by-pass it was not possible to obtain any water hammer, but a violent fluctuation of the mercury gauge and peculiar sounds in the valve when it "fired" would indicate that there was some movement of the movable member. Apparently, we have reached a size of by-pass which is nearly large enough to safely carry the flow from the lower chamber to the upper chamber.
